# Moab UMTRA Project Flood Response Summary

Revision 0

October 2014

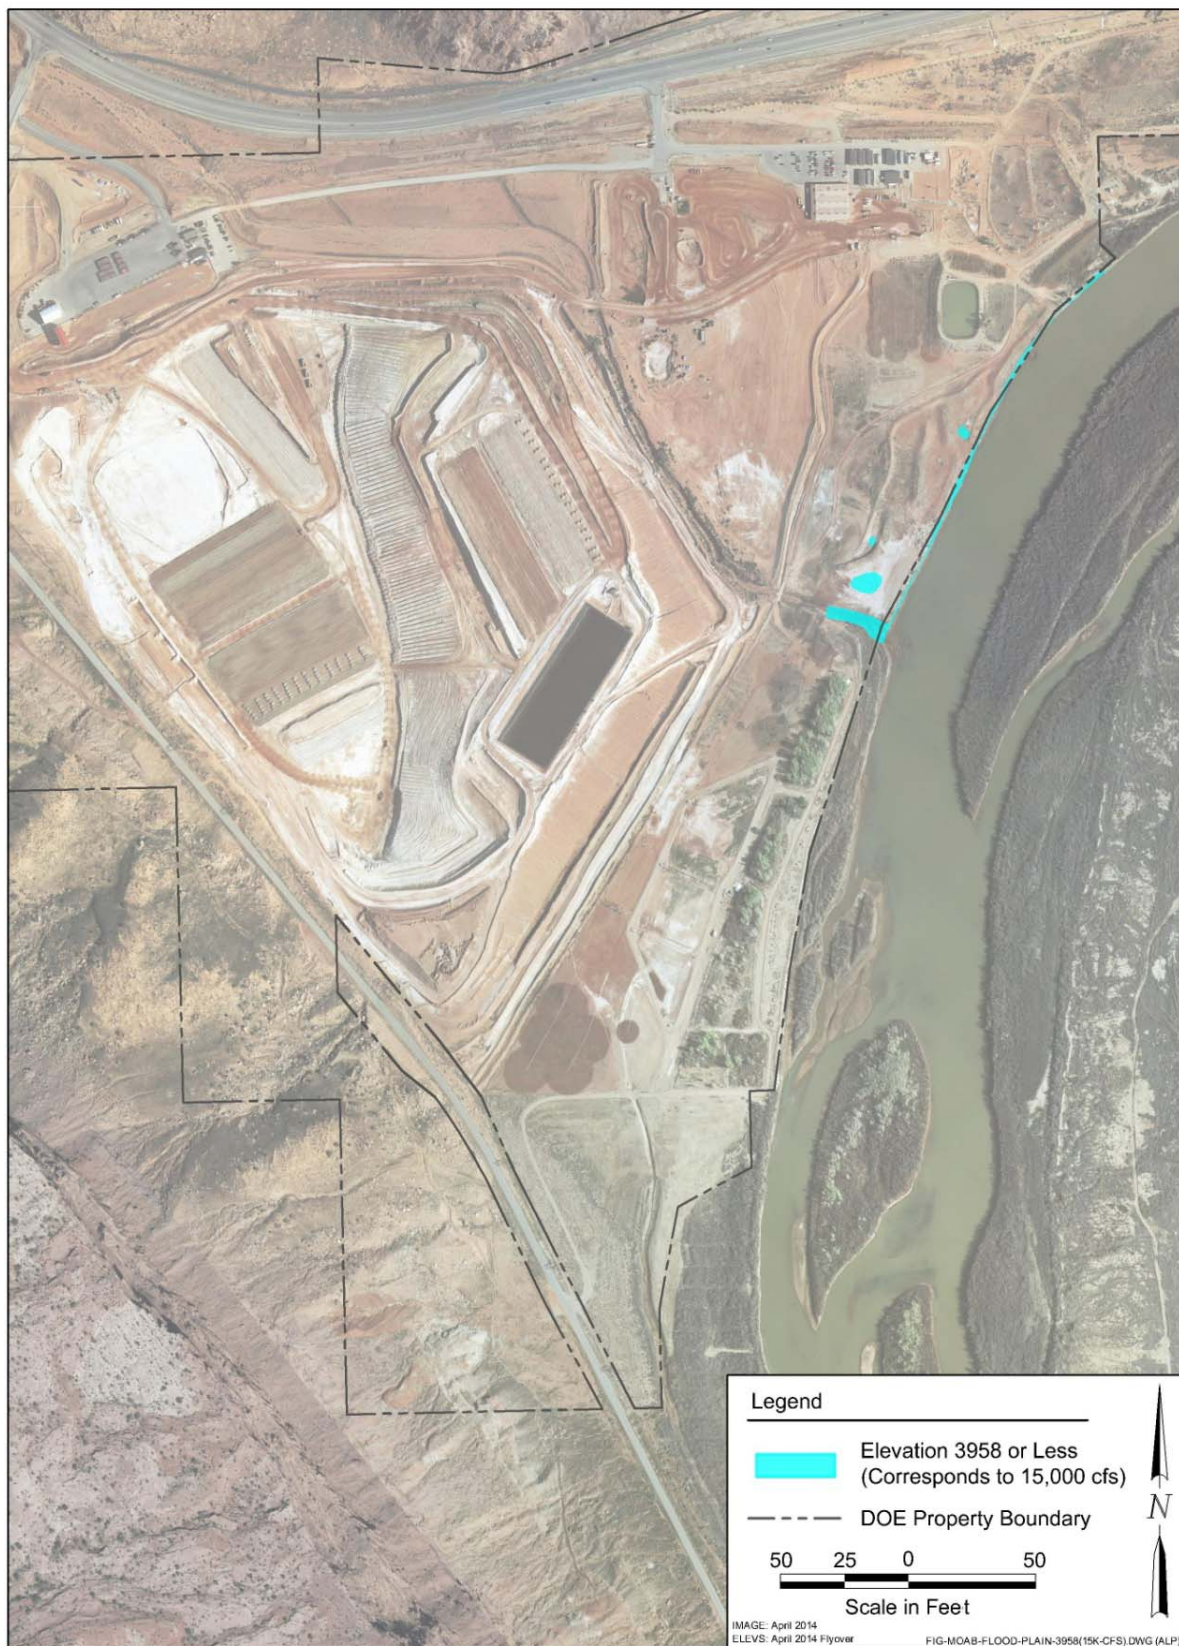
Figure 5. Floodwater on Site at 15,000 cfs

By May 22, when the river flow was 15,200 cfs (3958.0 ft amsl), water had backed about halfway up the Moab Wash to the lower crossing, and the river exceeded its bank and began to inundate the north off-pile area (Figure 5). By May 27, the river flow was 22,600 cfs, most of the area was flooded, and the access road was closed.

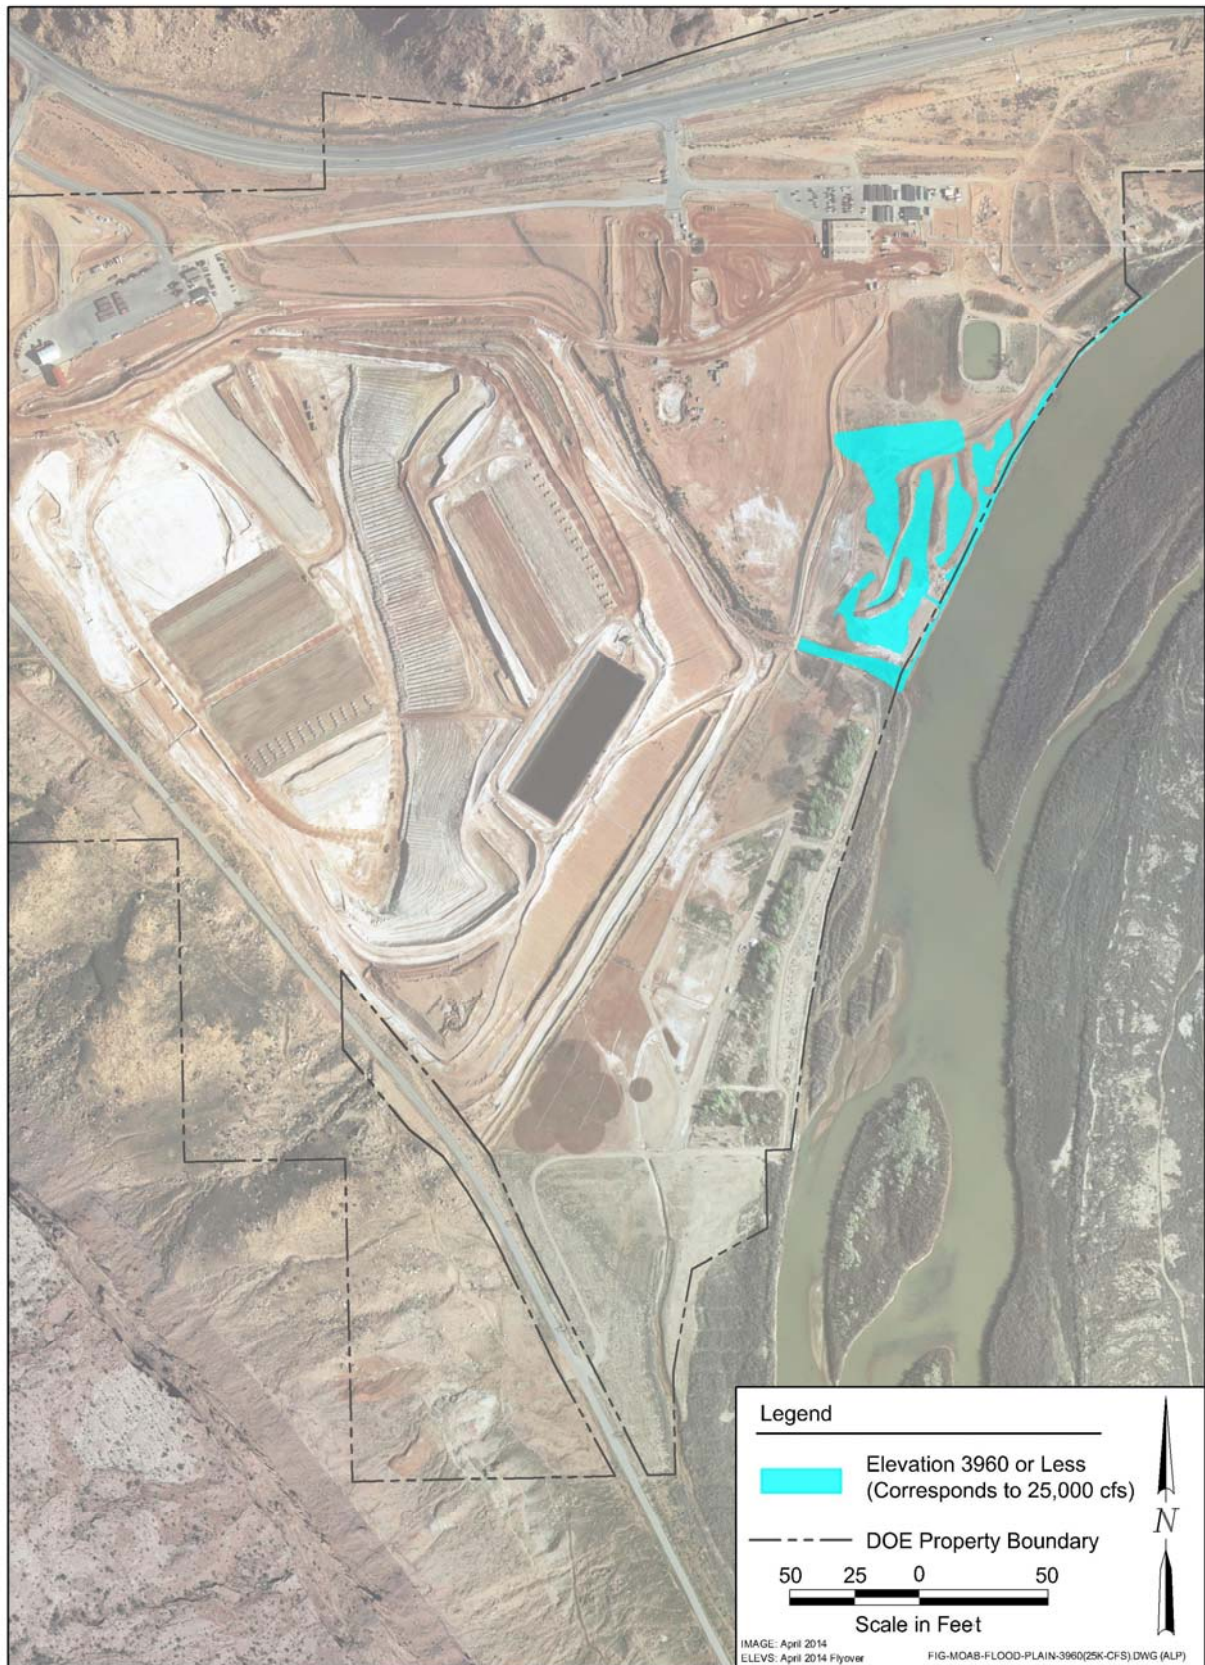
Figure 6. Floodwater on Site at 25,000 cfs

On May 30, when the river flow was 28,100 cfs (3,962.8 ft amsl) (Figure 6), the wash lower crossing flooded.

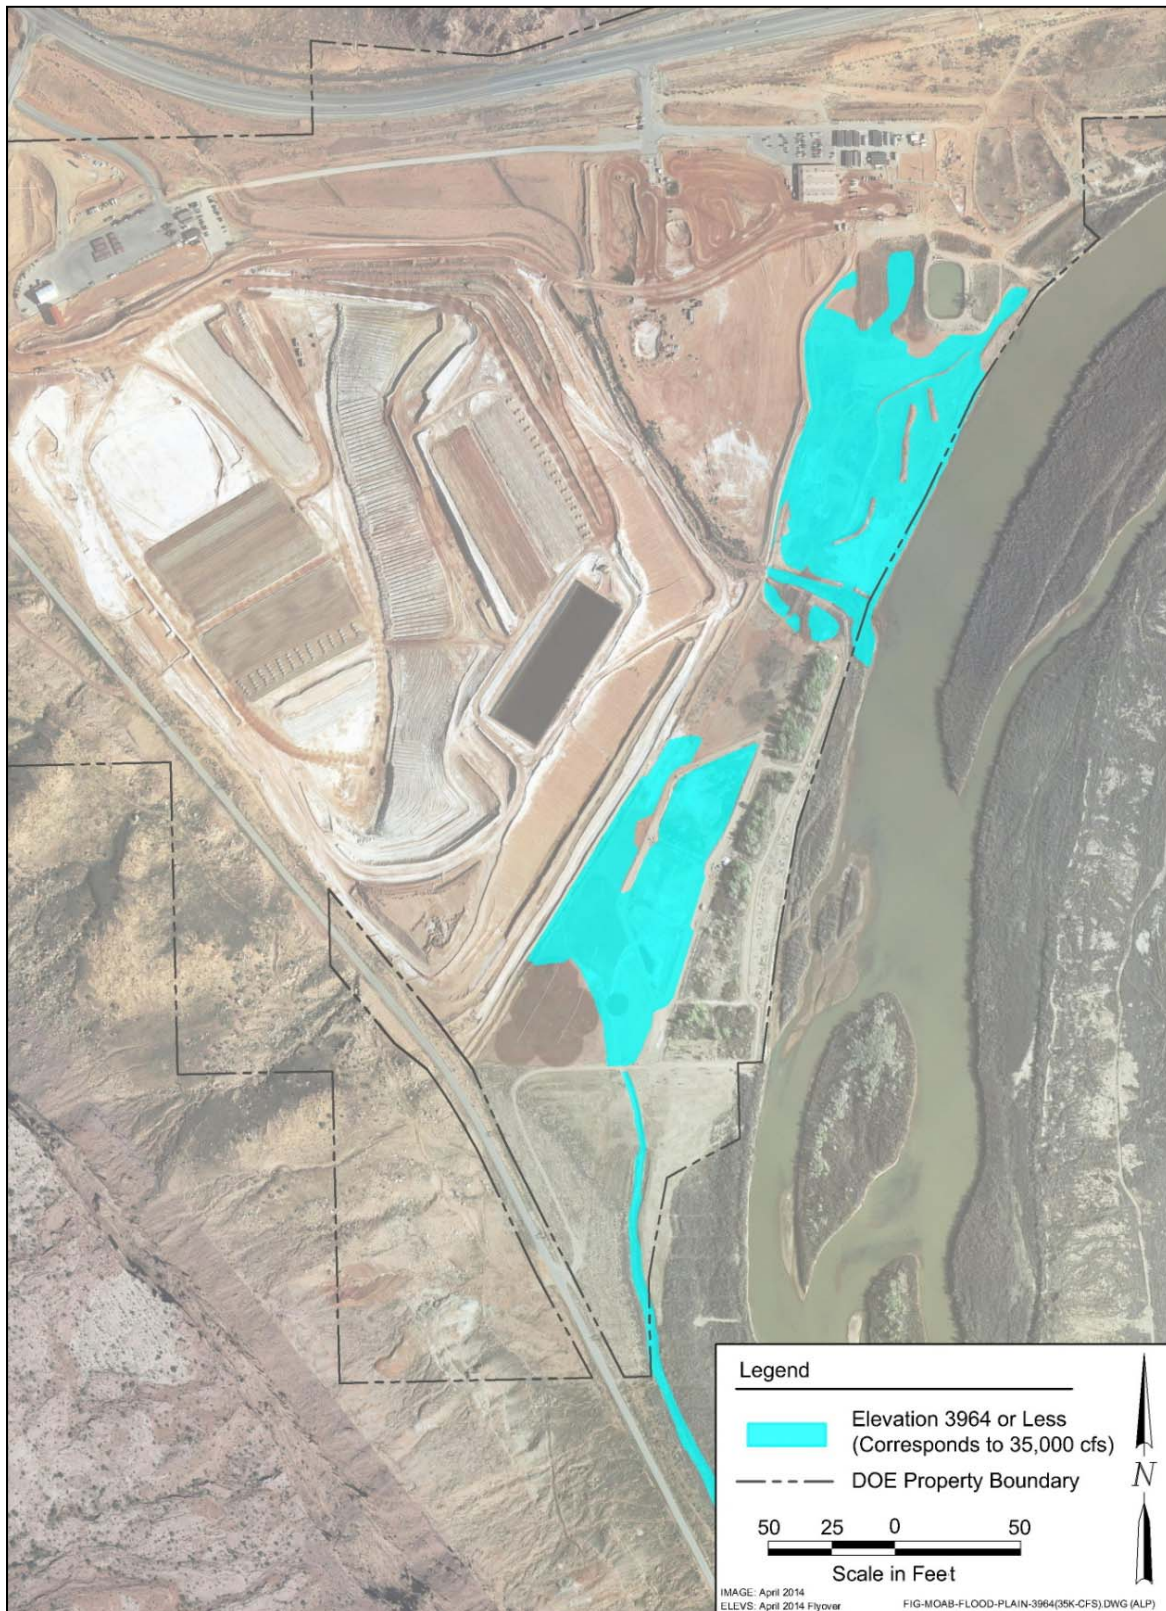
Figure 7. Floodwater on Site at 35,000 cfs

On June 3, when the river flow was 37,200 cfs (3,964.9 amsl) (Figure 7), water began to flow northwest through the drainage channel and eventually flooded nearly all of the well field area. The depth of the water varied from a few inches to nearly 3.5 ft on the western side near the Contamination Area (CA) boundary. Based on the elevation of the channel, water was expected to flow through to the well field area at 25,000 cfs. There was likely debris and/or vegetation blocking the channel south of the DOE property boundary.

Later on June 3, when the river peaked at 37,500 cfs (3,964.7 ft amsl), a nominal amount of water flowed over the Moab Wash southern berm spillway and across the nearby well field access road. During inspection of accessible berms, TAC staff identified a fracture in the southern berm of the wash. The fracture was approximately 20 ft long and several inches deep.

On June 3, TAC staff placed soil behind the Moab Wash southern berm fracture to reinforce the area.

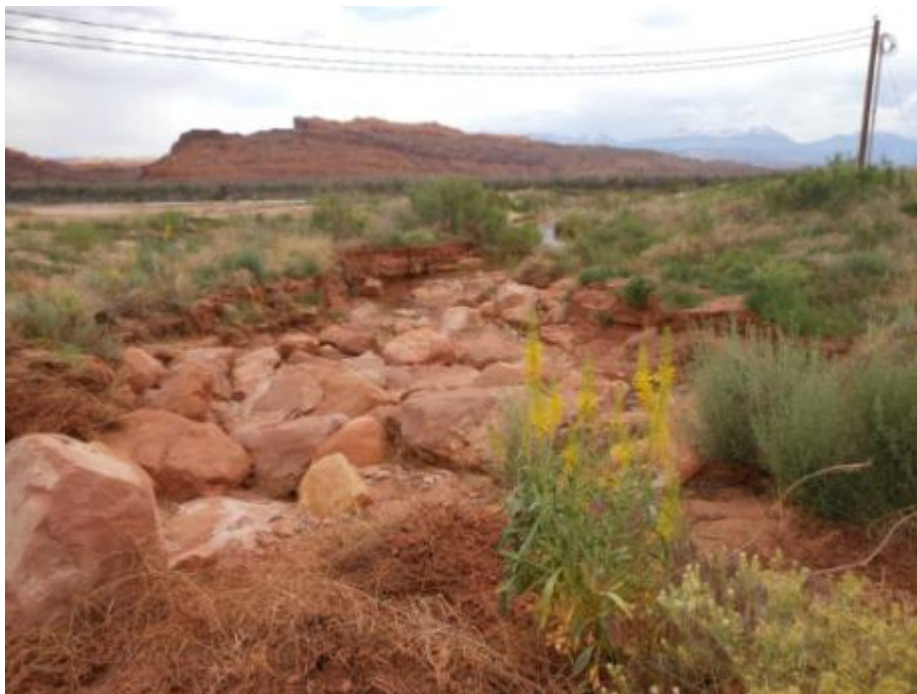
May 22, 2014  
15,200 cfs; 3958.38 ft amsl

*Photo A-1. River Water Backing Up into Lower Reach of Moab Wash*

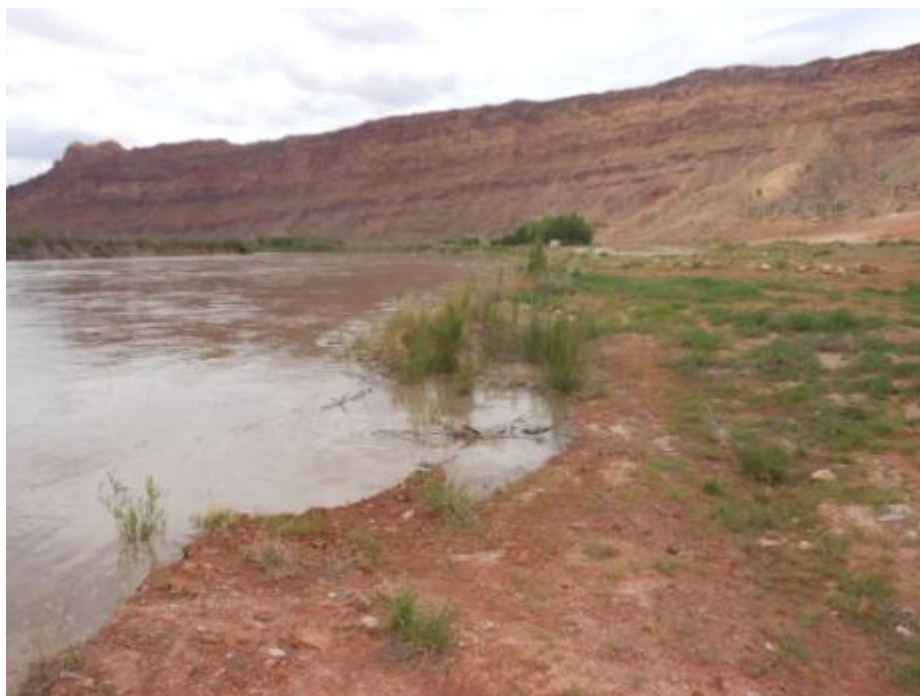
*Photo A-2. Floodwater Entering North Off-pile Area*

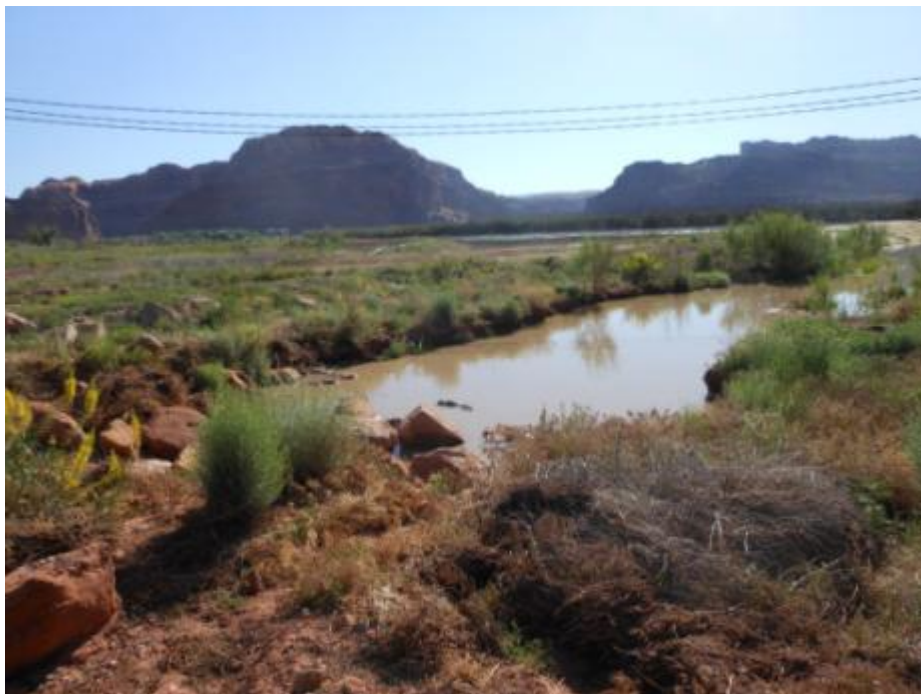
May 27, 2014  
23,000 cfs; 3961.0 ft amsl

*Photo A-3. River Water Backed Up into Lower Reach of Moab Wash*

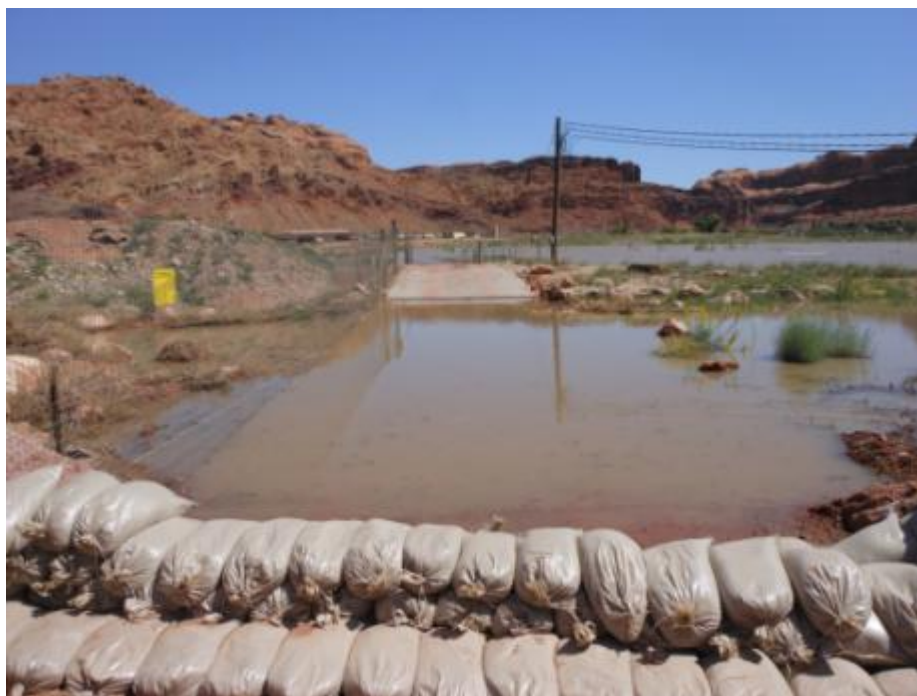
*Photo A-6. Moab Wash Lower Crossing*

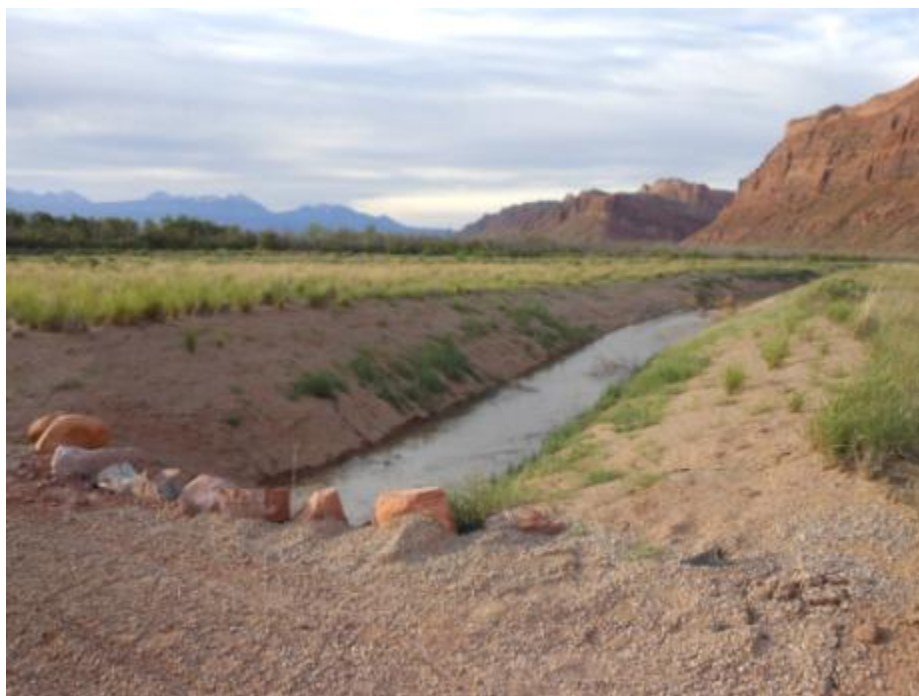
**June 3, 2014**  
**37,200 cfs; 3964.9 ft amsl**

*Photo A-8. Drainage Channel through South Off-pile Area*

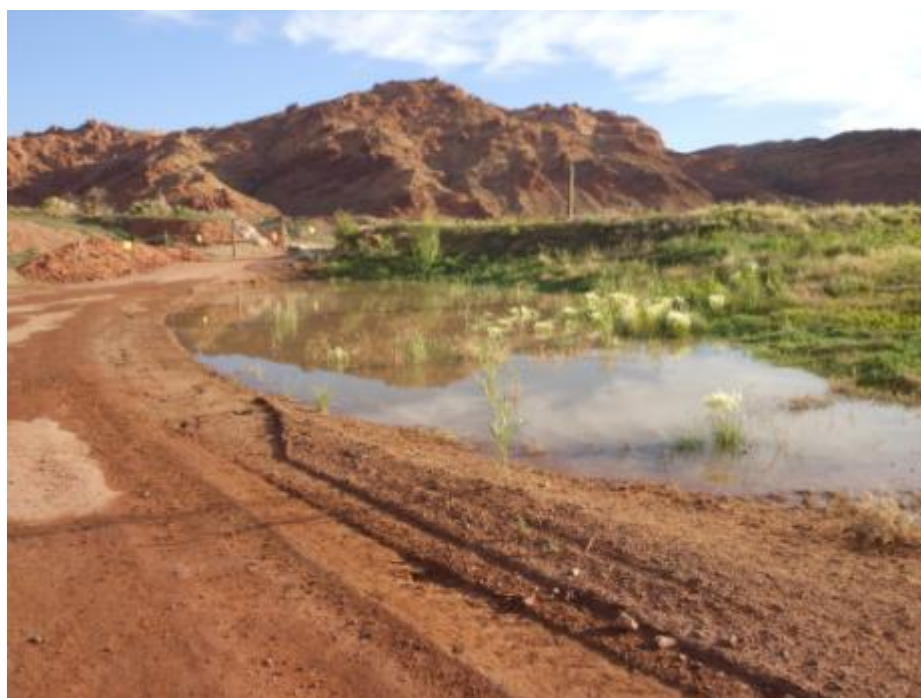
*Photo A-10. Ponded Water Just South of Moab Wash*

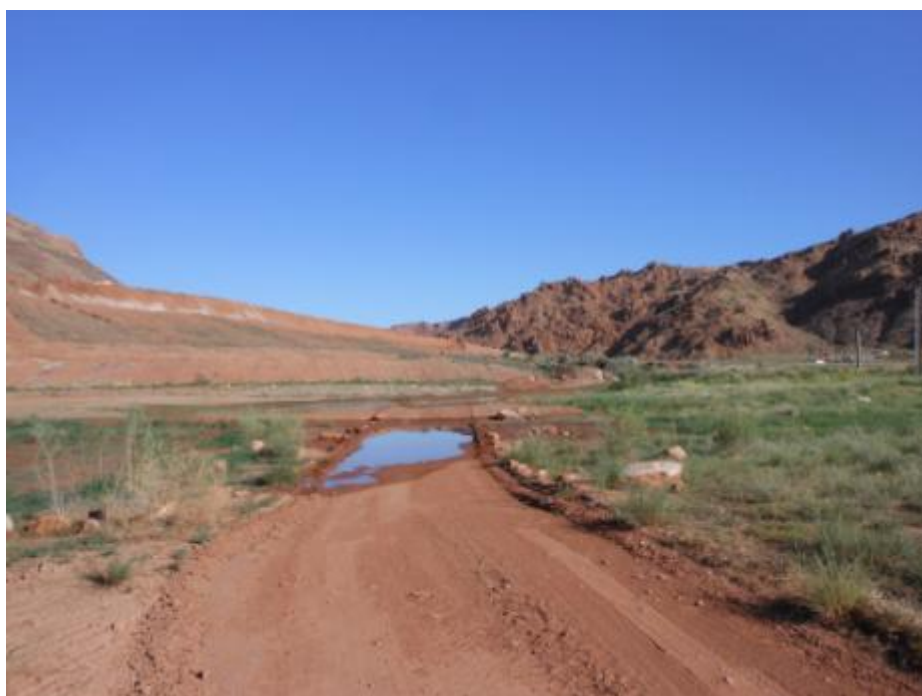
*Photo A-13. Floodwater on Road in Well Field Area*

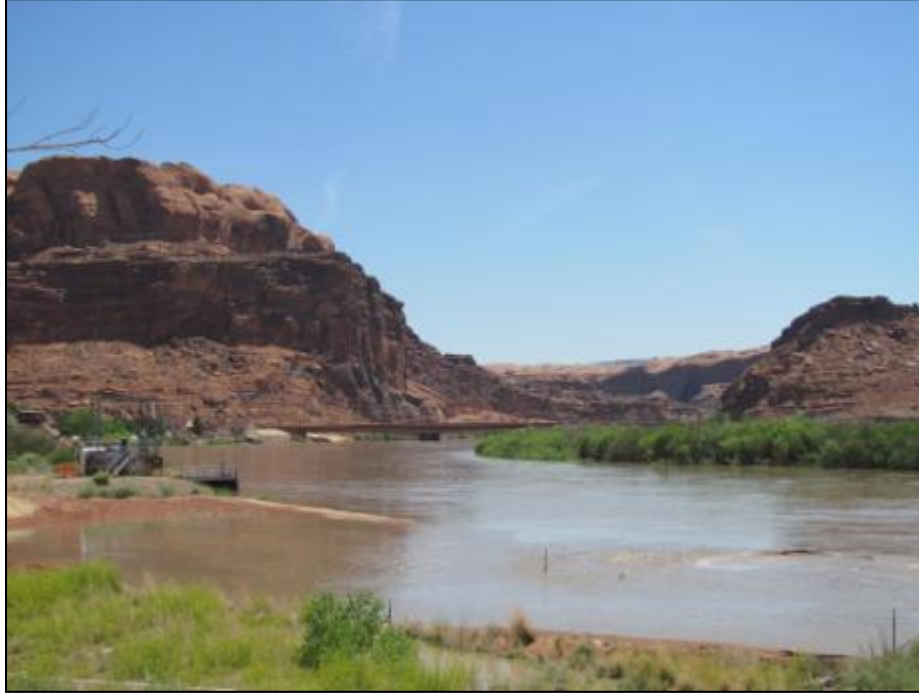
**July 1, 2014**  
**11,600 cfs; 3965.7 ft amsl**

*Photo B-1. Floodwater in North Off-pile Area*

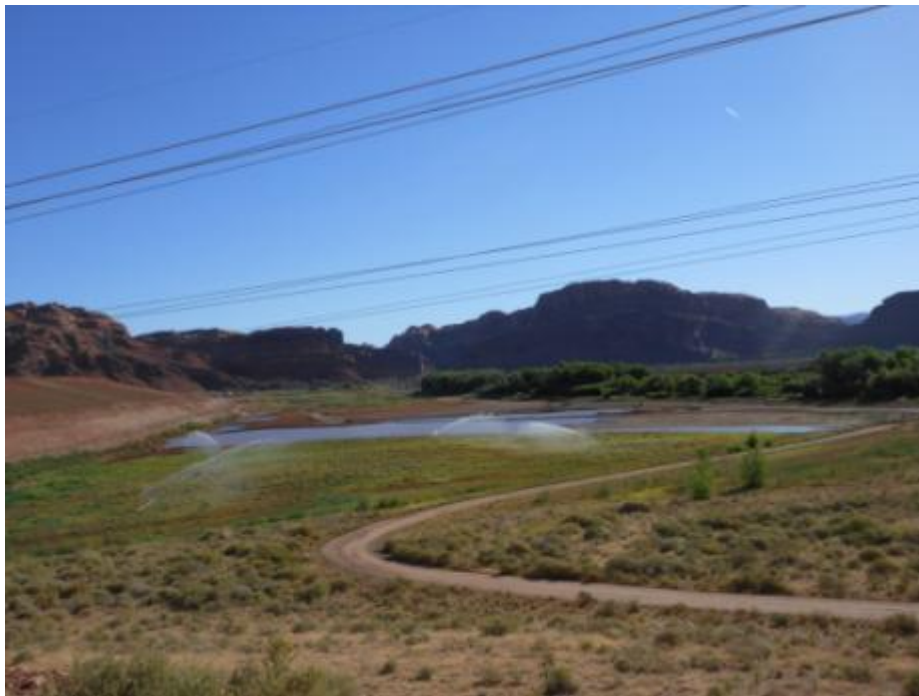
*Photo B-2. Floodwater in Well Field Area from State Route 279*

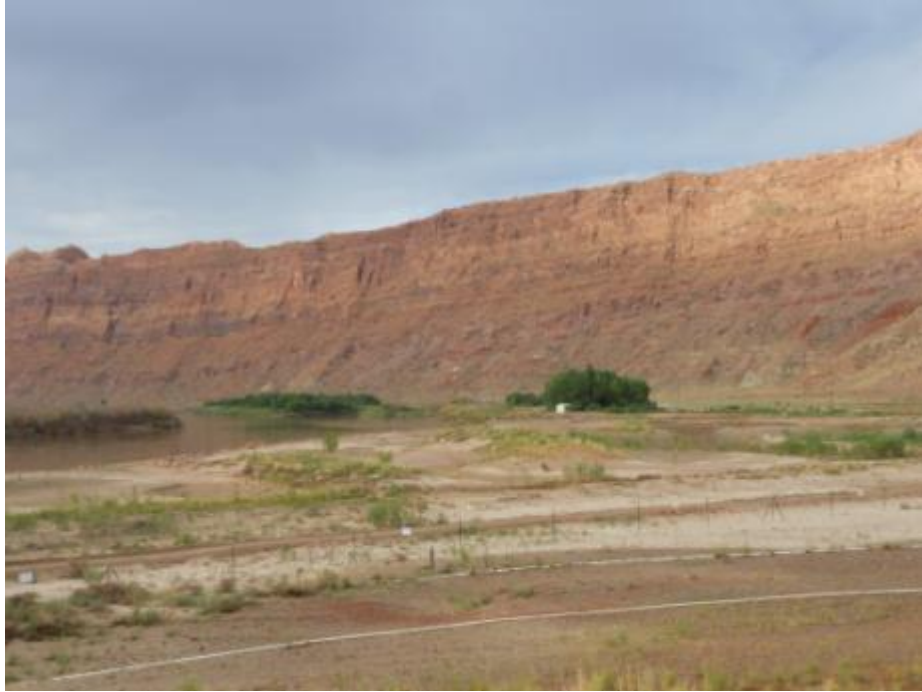
July 10, 2014  
7,610 cfs; 3955.3 ft amsl

*Photo B-3. Nearly Dry North Off-pile Area*

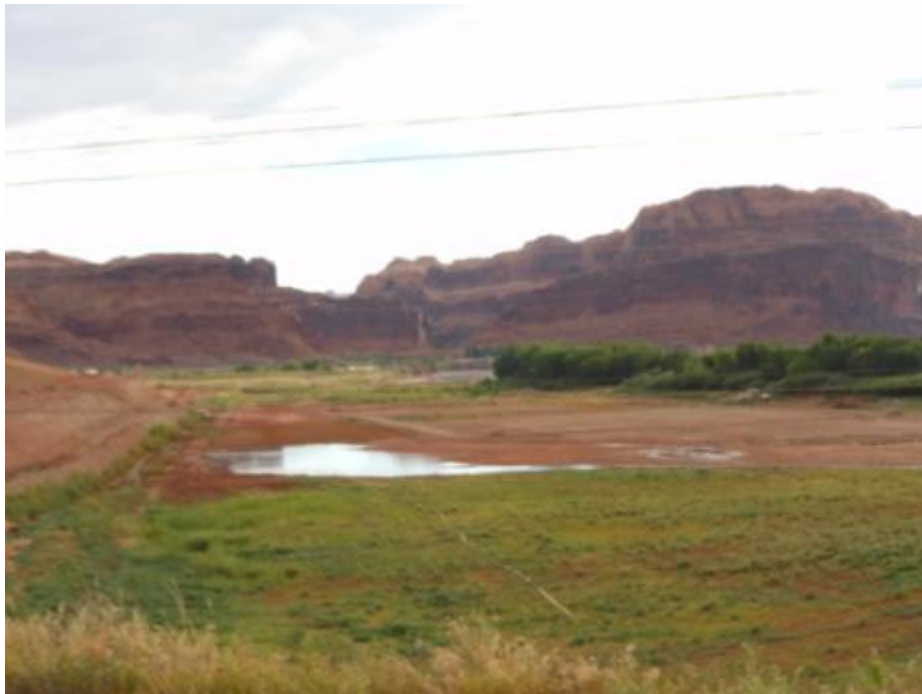
*Photo B-4. Well Field Area Floodwater from State Route 279*

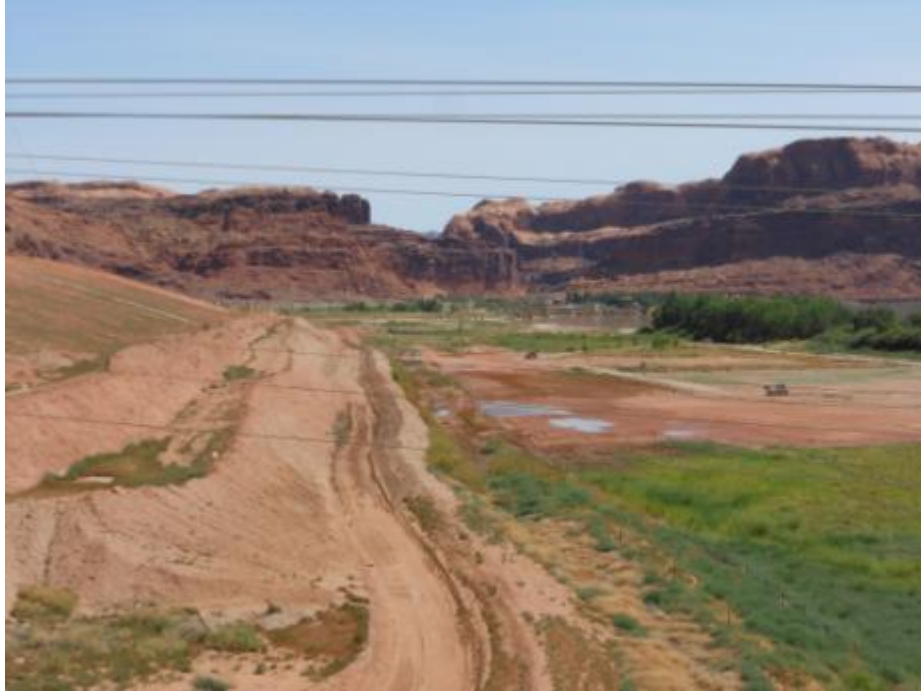
July 17, 2014  
6,380 cfs; 3954.7 ft amsl

*Photo B-5. Well Field Floodwater from State Route 279*
